**National Register of Historic Places
Registration Form**

historic name Mt. Zion Memorial Church, S-405

other names Mt. Zion Methodist Episcopal Church

state Maryland code MD county Somerset code 039 zip code 21853

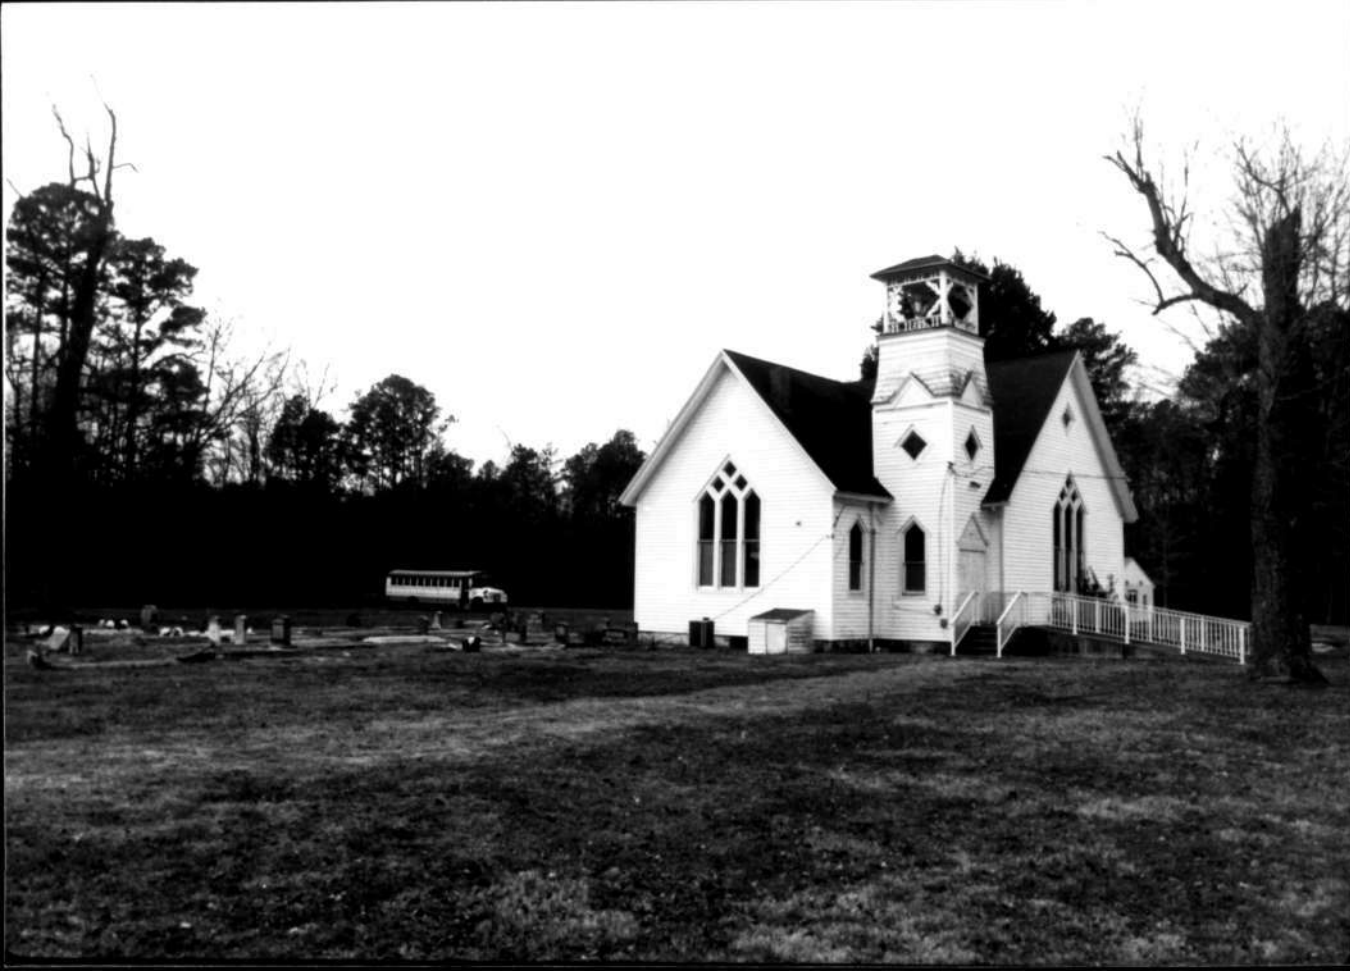
1 of 5

Mt. Zion Memorial Church
Princess Anne Vic., Somerset Co. Md.
Northeast Elevation

The north (main) elevation is an asymmetrically arranged façade with a three-story entrance tower rising in the northeast corner of the T-plan. A double-door entrance pierces the first floor of the tower and diamond shaped windows mark second story. The top of the tower tapers slightly as it rises toward the open belfry. The tapering portion of the tower is sheathed with wood shingles. The belfry is distinguished by Victorian sawn brackets and paired spindles across the bottom and top levels of the belfry opening. The belfry is capped by a short pyramidal roof, which is a modification of the original spire. Defining the adjacent gable-front wall of the main body of the church is a Gothic inspired tripartite window filled with early twentieth-century colored and opaque glass panes. The edges of the roof are finished with an extended eave. Piercing the front edge of the roof is a single flue chimney stack.

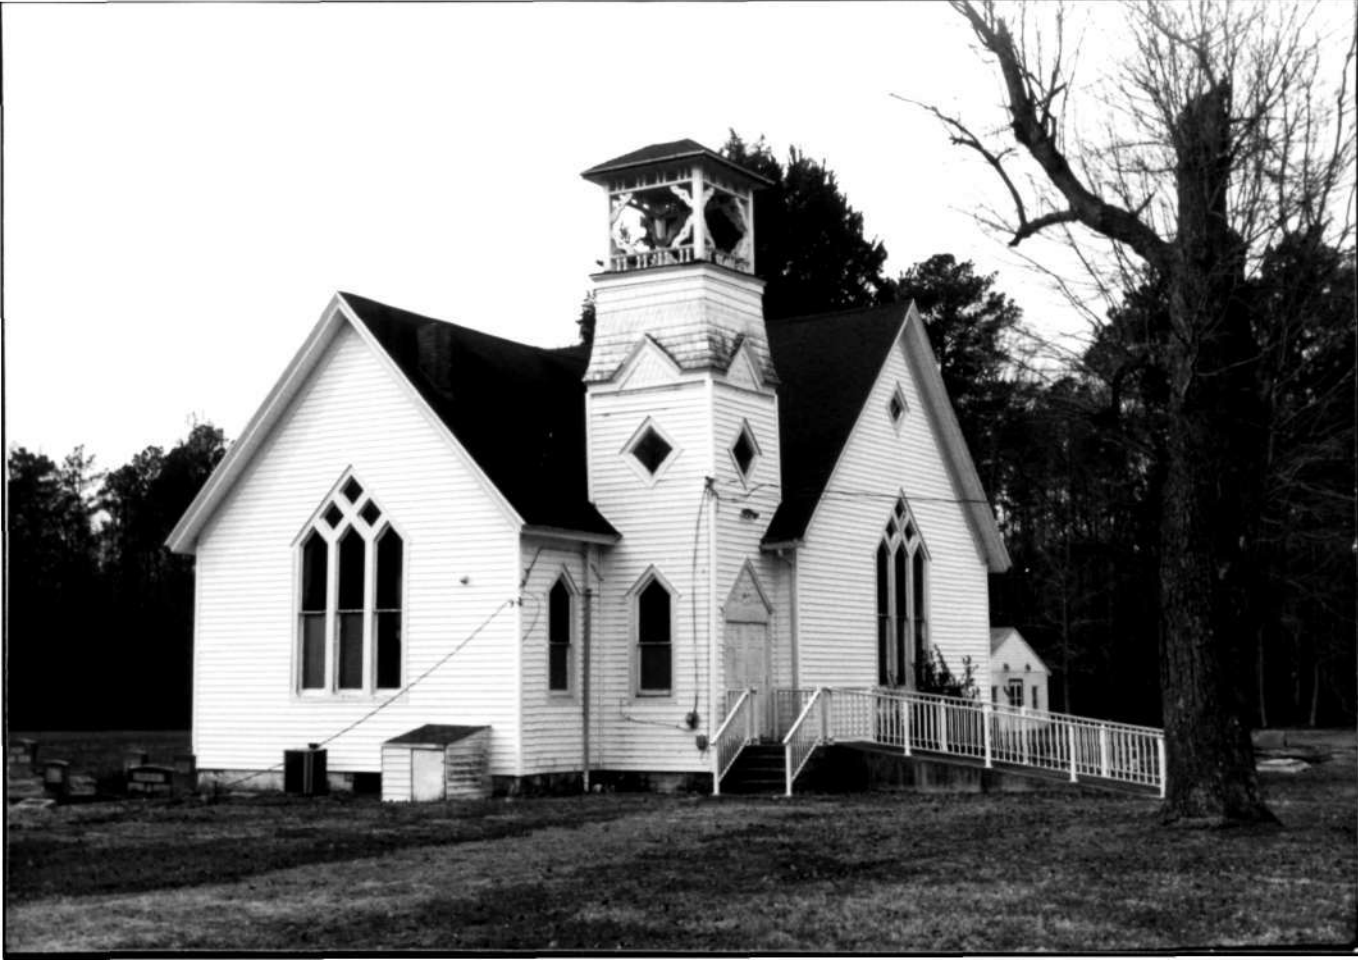
2 OF 5

NORTHEAST ELEVATION

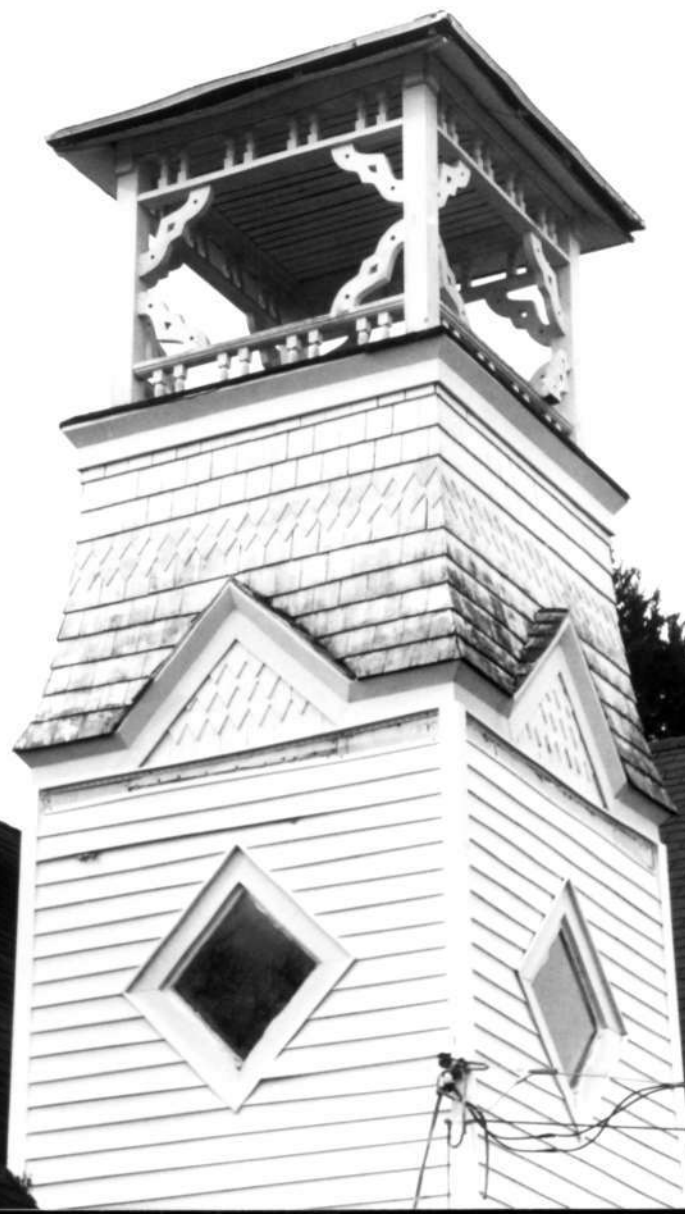
3 of 5

Steeple - NE Elevation

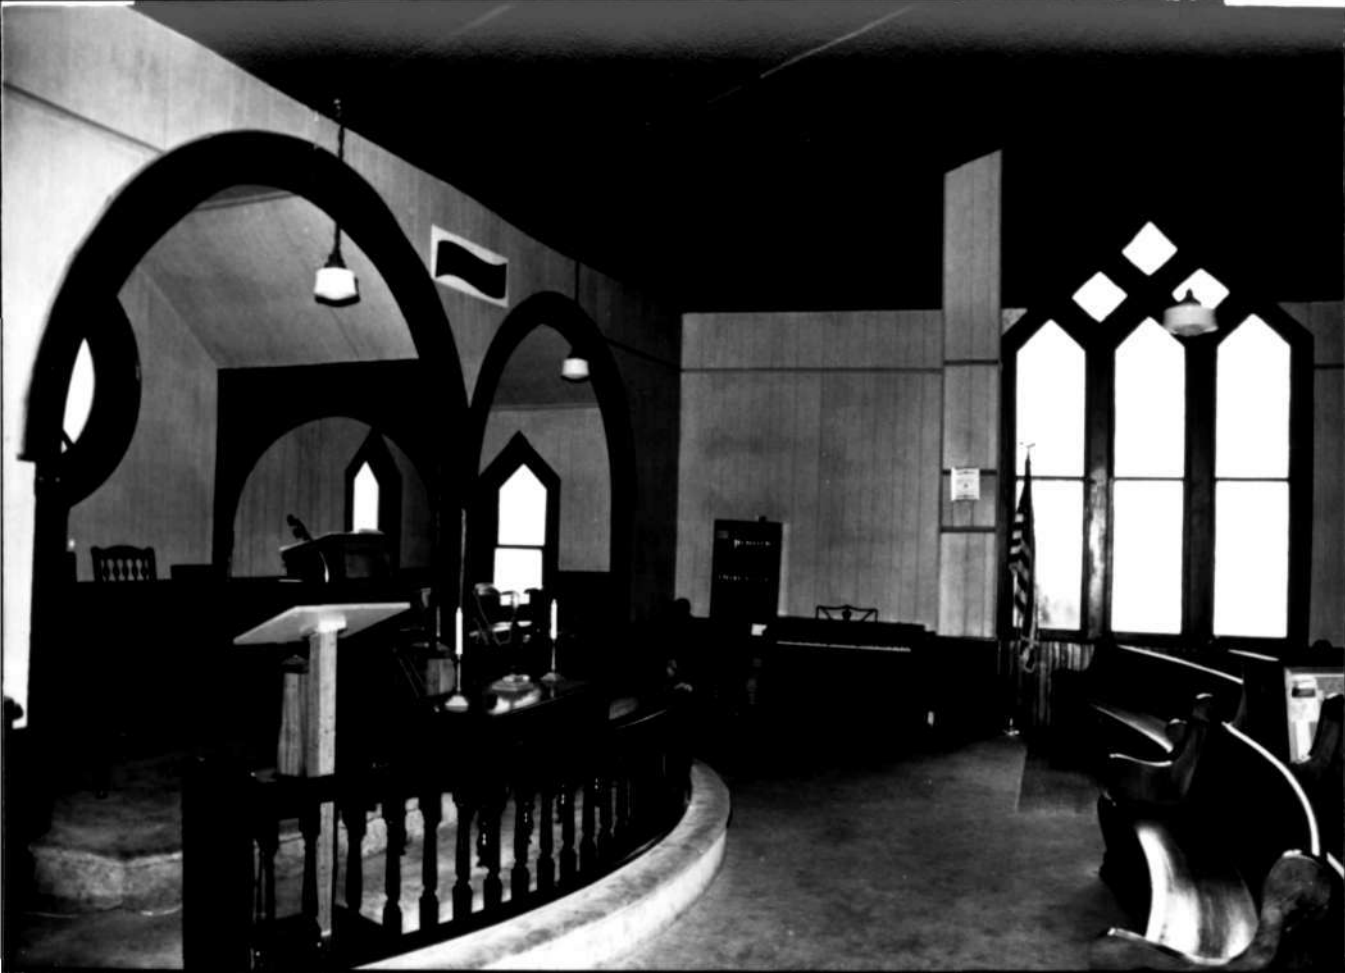
Mt. Zion Memorial Church
PRINCESS ANNE VIC, SOMERSET Co. Md.
Sanctuary - ALTAR - WEST & NORTH WALLS
2/06, PAUL TONART, PHOTOGRAPHER
4 of 5

The church interior survives with a blend of finishes dating from the 1887 and 1916 building programs. The main sanctuary occupies the rectangular center section of the church with the altar and choir to the west. In the east leg of the T-plan is an adjacent seating section housed in a room that can be closed off with a folding set of paneled doors. When the seating demands require, the two spaces can be consolidated into one large space. It appears, through the pervasive use of wire nails, that the interior was significantly remodeled in 1916. The sanctuary is trimmed with two periods of vertical board wainscoting. The wainscoting that distinguishes the sanctuary is finished with a layer of oak graining, whereas the wainscoting around the altar and choir areas is distinctly different with a dark mahogany stain. The use of wire nails indicates the altar, choir, and vestment room were reworked in 1916. The altar and choir are distinguished by round arched openings and turned baluster railing that stretch across each area. The turned baluster altar rail is semi-circular. One of the most distinctive finish features of the interior is the early twentieth-century beaded board ceiling. A gridwork of panels, fitted with alternating diagonal tongue-and-groove boards distinguishes the ceilings of the main sanctuary east wing. Bulls-eye blocks mark many of the points where the panel framework meet. Hanging from the ceiling are the original 1916 milk glass style globe chandeliers.

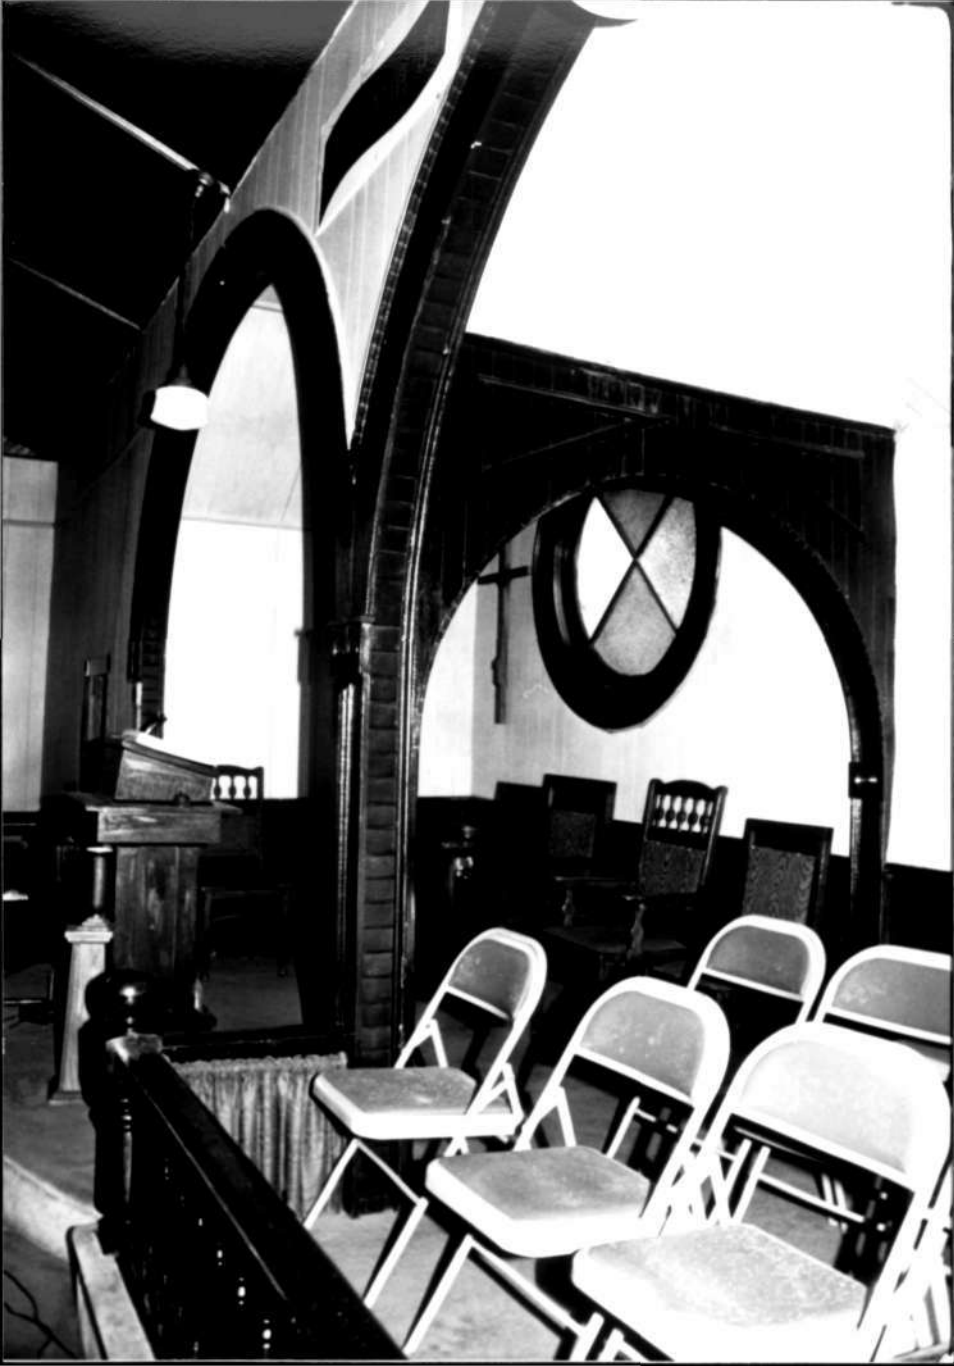
5 or 5

SANCTUARY. ALTAR

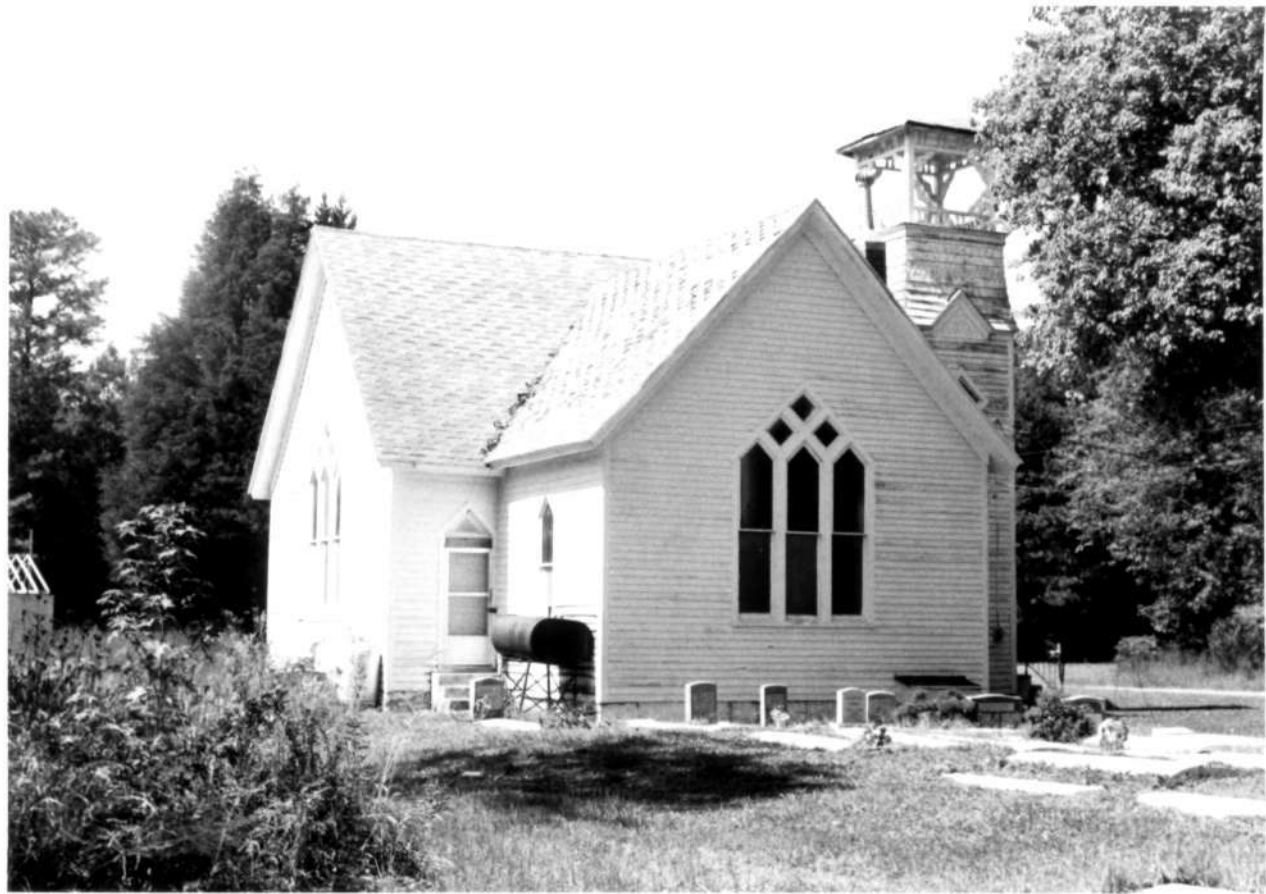
Southeast elevation

The south (rear) elevation is an asymmetrically planned façade with the gable end of the sanctuary pierced by another Gothic inspired tripartite window fitted with early twentieth-century colored glass panes. The adjacent shed room to the west is marked by a door opening

The east elevation of the T-shaped church is finished in a similar fashion with the gable end wall pierced by another Gothic inspired tripartite window.

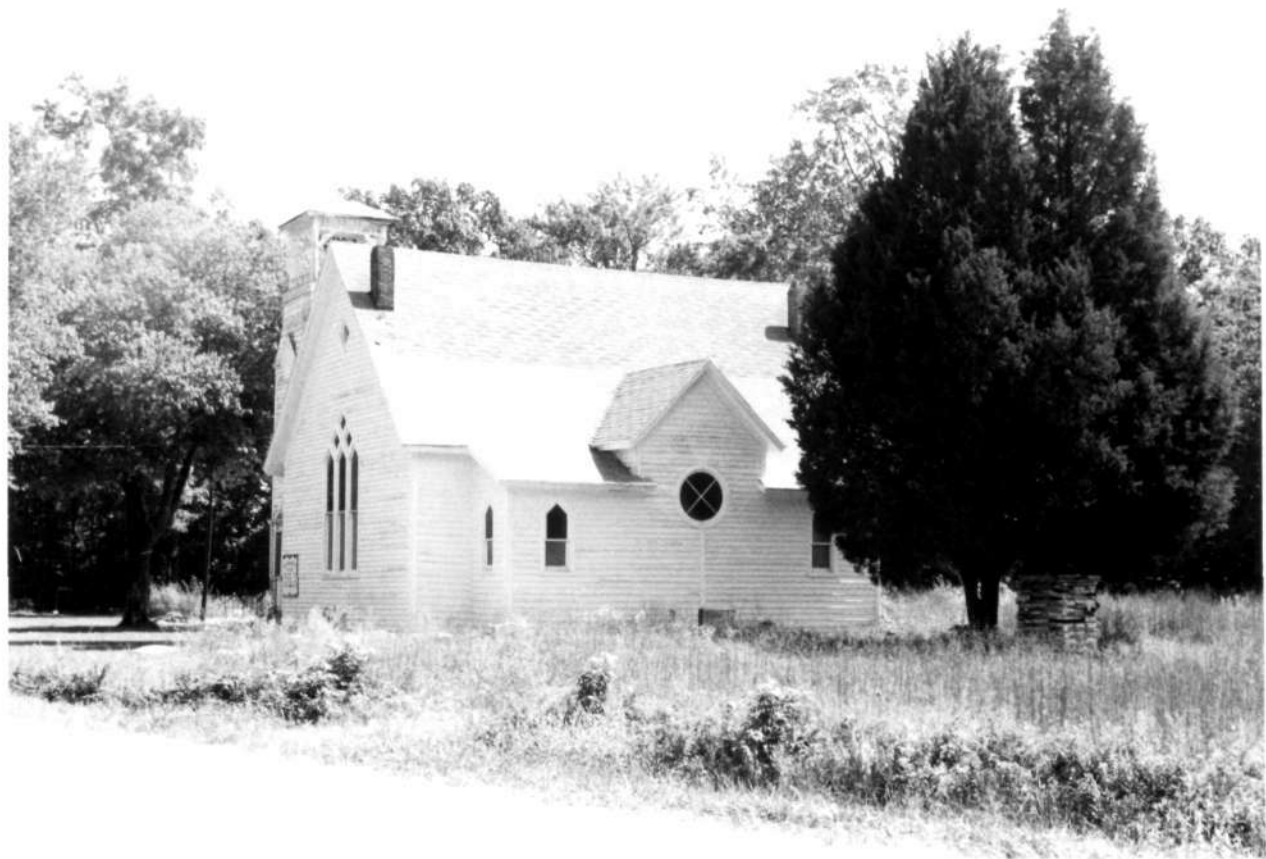
MT. ZION MEMORIAL CHURCH S-405
Mt. Vernon vic. Somerset Co., MD
North west elevation
7/86 Paul Touart, photographer
Negative/MD Historical Trust

The west side elevation is defined by a single story gable roofed structure flanked by shed roofed side sections that extend from the main body of the church and house the altar area, choir and an adjacent vestment room. The altar wall is pierced by a round colored glass window, and the shed roofed sections are pierced by Gothic inspired single-pane colored glass sash.
